## Site

1041 NE 100<sup>th</sup> Street  
Seattle, WA 98125

## Summary of Subject Tree Characteristics

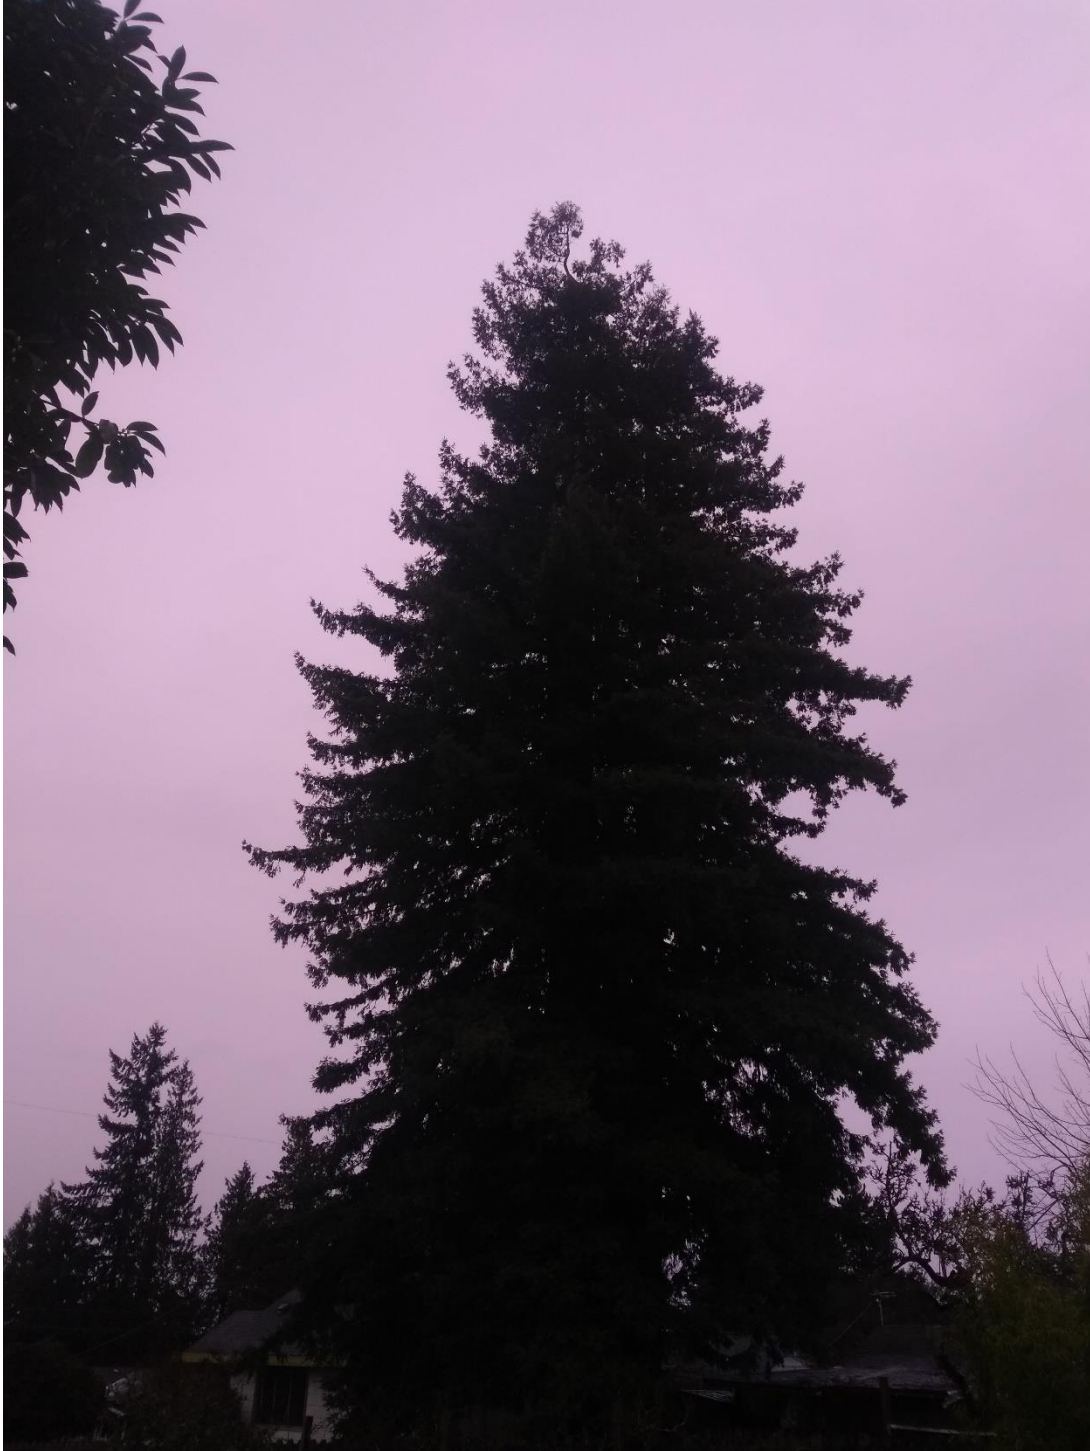
Showing full tree from SW alleyway. Notice extra dense, fairly even diameter canopy to 65', also missing 15' of the right top.

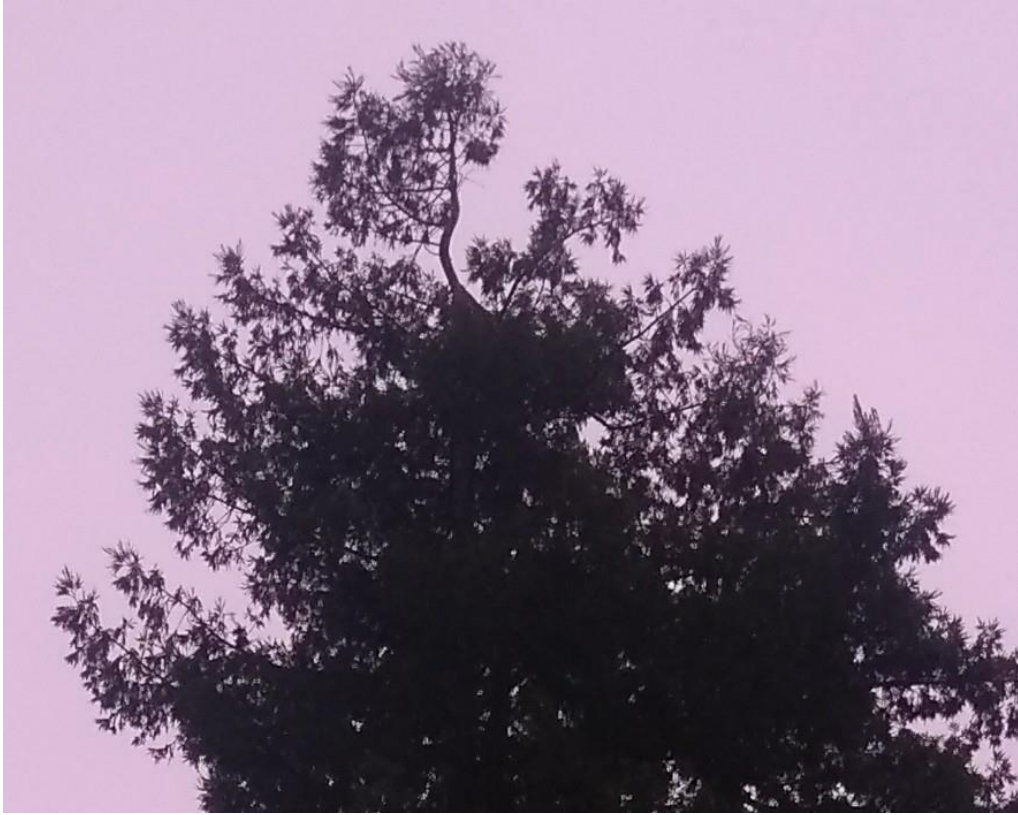
Closeup of top showing hole in canopy.

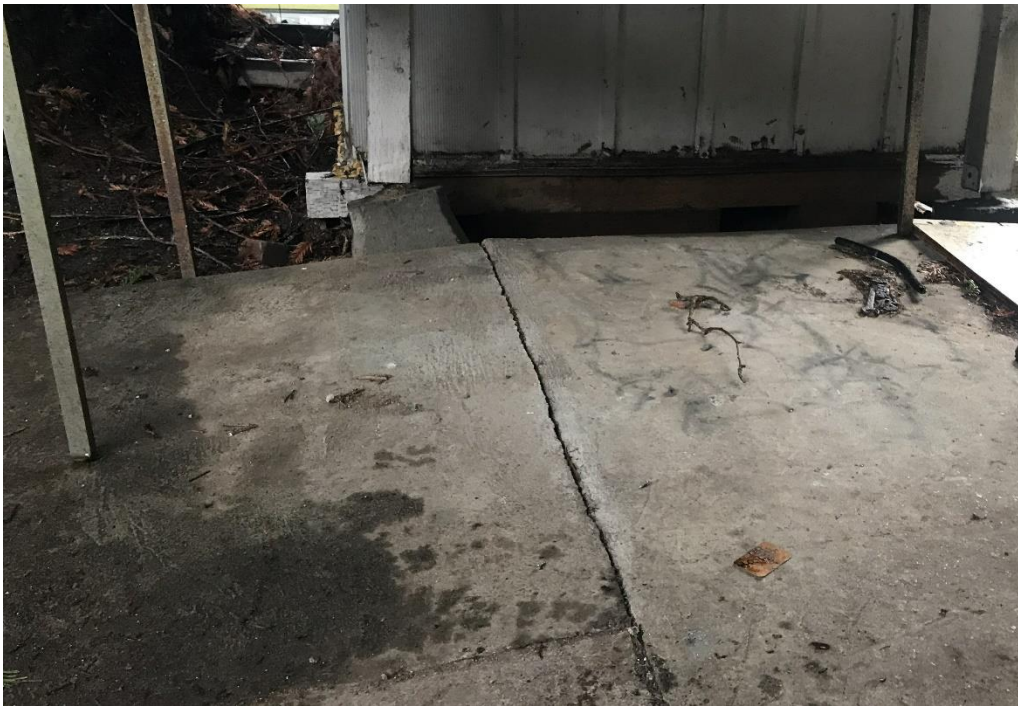
Showing degree of lift of concrete slab to S of subject tree.

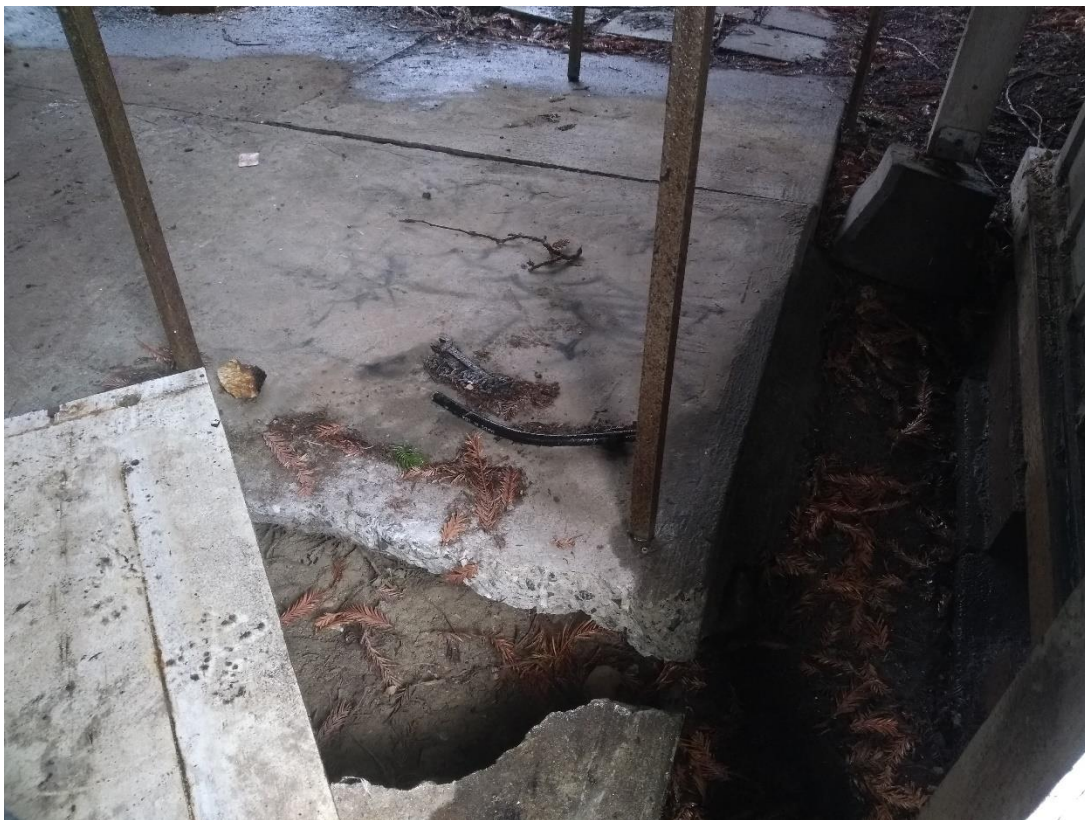
View of concrete slab with lifted 'peak' of concrete removed by previous owner.

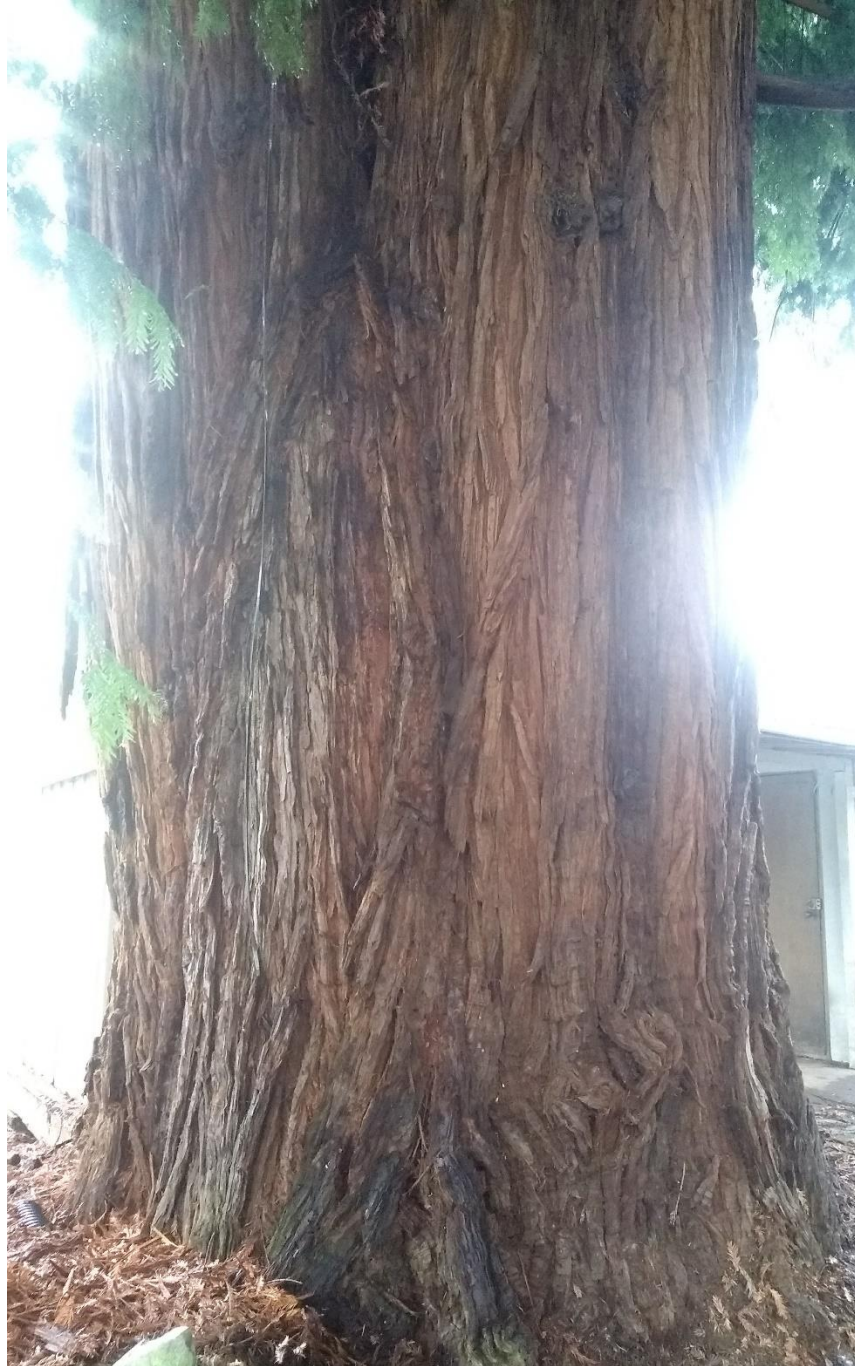
View of stem looking N. Notice 2 bark furrows under S join discolored, with slight bulge between.

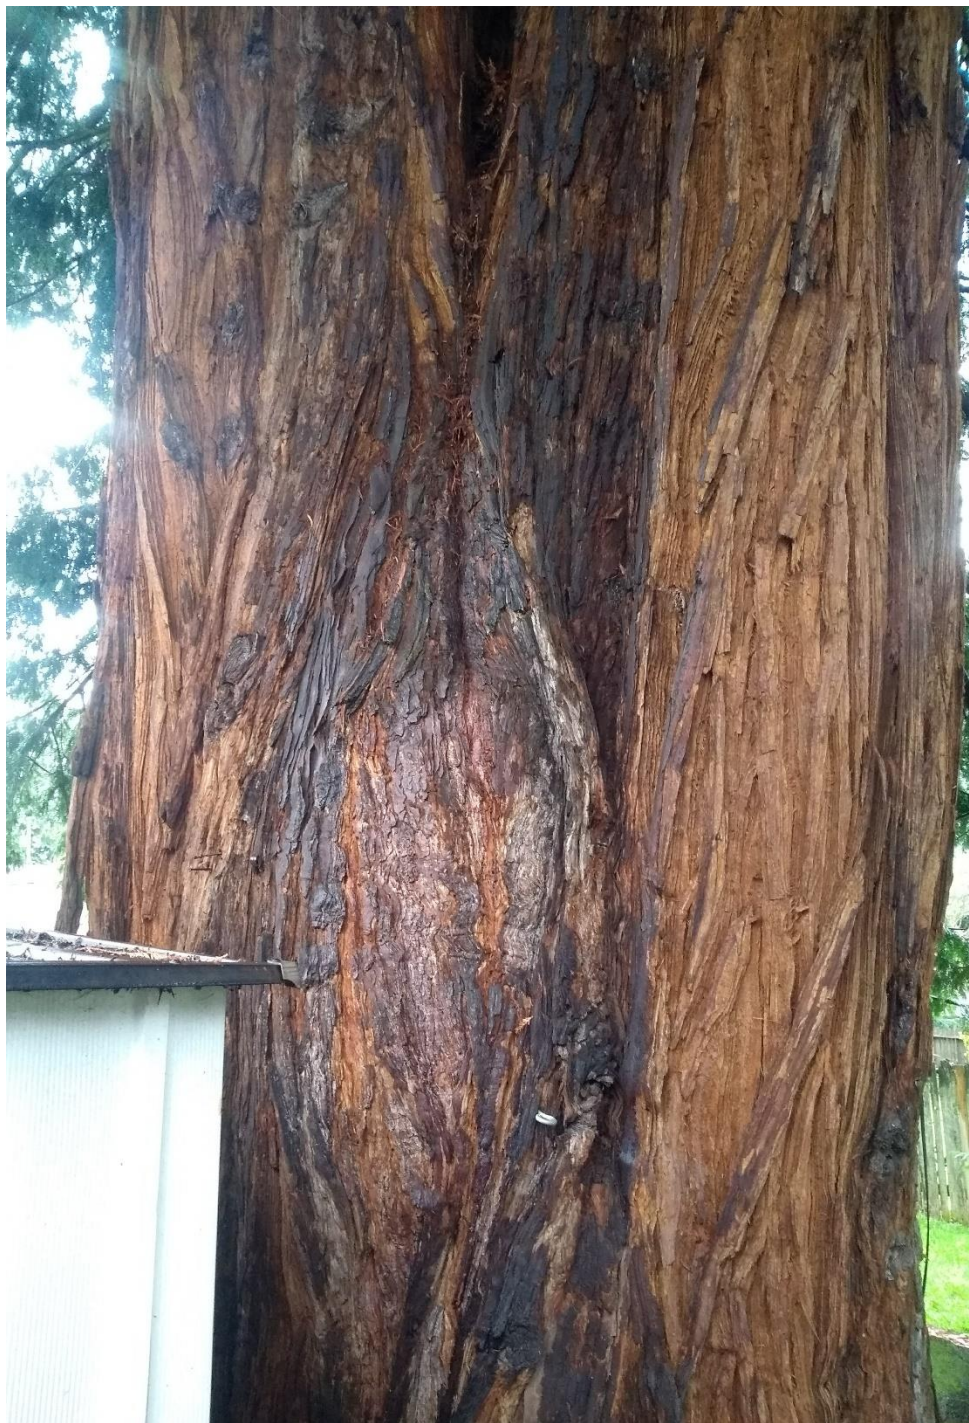
At first, with mist in the air, the tree looked healthy with a dense canopy coverage of 40-45' in diameter continuing to 65' in height where it gradually tapers towards the top. However, gaining the bottom of the tree through the alleyway, after the surprise of the large girth of the tree had passed, I immediately saw numerous large stems originating from multiple, but similar, heights denoting **multiple prior topping episodes**. All joins were acutely angled except one I saw, from the SW alleyway, where one half of one stem had failed, leaving the other half, which has an obviously curved (stronger) join. Looking down, only one root of any girth can be seen, it being a significant buttressing root traveling SW less than 10' before diving underground. Just to the N of it on the lowest portion of the main stem, a protruding bark strip drew my attention. At first I assumed it was cut at the base due to water lines being run, but upon further investigation (kicking, firm tugging) I found it to be solid in some way even though it sprung with an obtuse angle facing its origin. A different, more obviously natural defect is just above this one and shows a less but still significant bark buckling, seen both by protrusion and by changing bark textures. A coated cable of some type was seen running up the northern most stem of the NE stem group. This could possibly explain the similar reduction of the three highest tops @ 100', rather than assuming all three failed at similar heights less than ten years ago (I bet an antenna of some variety is lodged in the topmost canopy.). Checking around for more of this type of significant bark defects, I did not see any but did see a significant (2'x3' ovoid) bulge under the E join. The darker furrow running down from the above join, with the significant bulge underneath denotes an area of interest/decay in the heartwood. All three joins have darkened furrows of bark underneath which shows passage of precipitation and/or signify a cavity(ies) in the middle of the tree oozing moisture. Just to the S of the major bulge on the stem is evidence of long use by raccoons signifying an increased debris load (raccoons have normal 'latrines' they use) in the crotches of the tree. The observed evidence of stem (bark) movement on the lowest W stem is a decisive element when compounded with the tendency of this tree to break when rotted, the significant bulge denoting rot under the E join, the wind directions/force, the limited root

View of ENE join with significant bulge denoting rot underneath.

**I recommend removal of the subject tree due to above mentioned defects causing it to rate a 'High' risk to surrounding houses with no chance of mitigation.** As this is a planted landscape element grown elephantine and hazardous, removal efforts will not be easy. Homeowner should assume large scale disruption of the backyard. Tree removal will certainly take a number of days and be costly. Grinding of the stump may take a number of days depending on how many rocks are found. Tree service personnel are cautioned this is currently an **EXTREMELY HAZARDOUS** tree to remove due to many metal elements driven/screwed into the lower stem, as well as holding the antenna/cable in place. A metal detector needs to be used for effect to lessen the hazard.

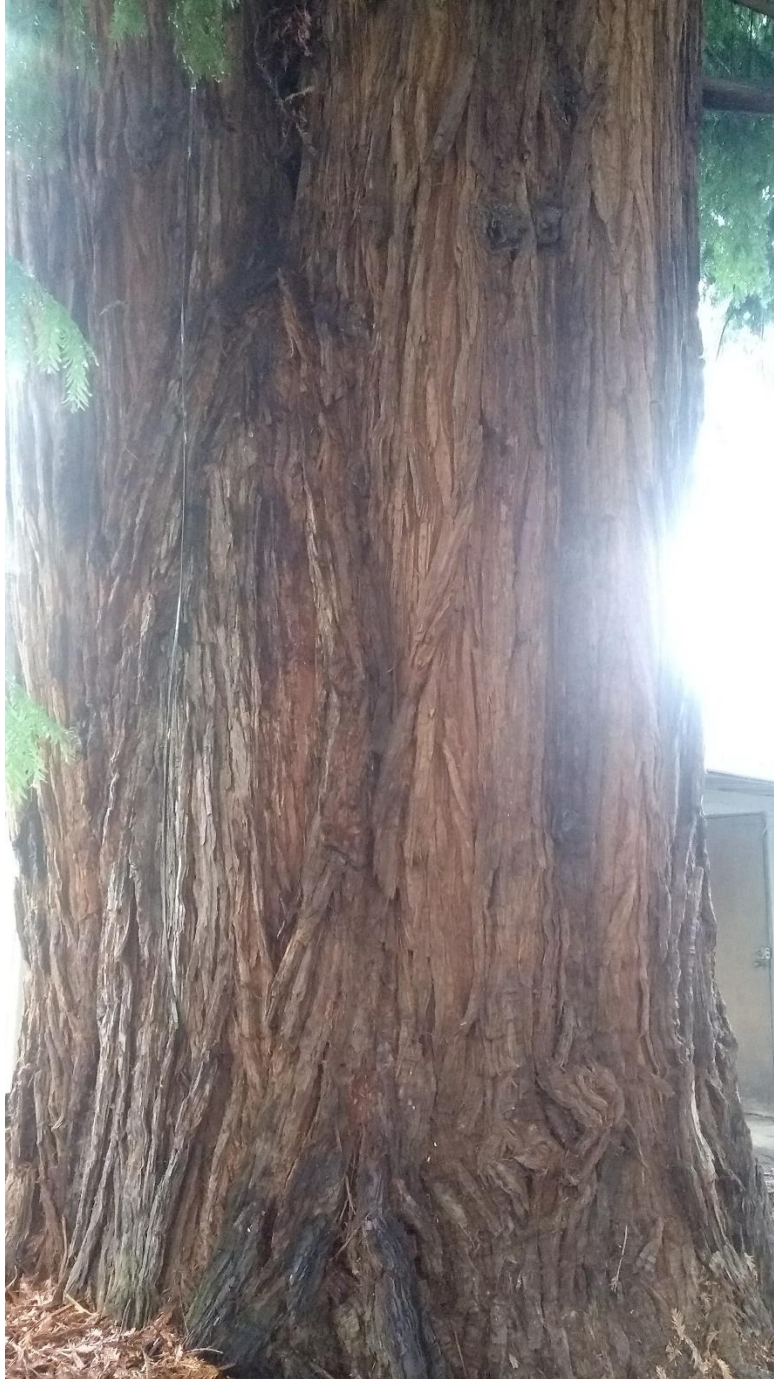
View of NW join showing cable running up center left and dark colored furrow running to dark colored sprung bark strip.

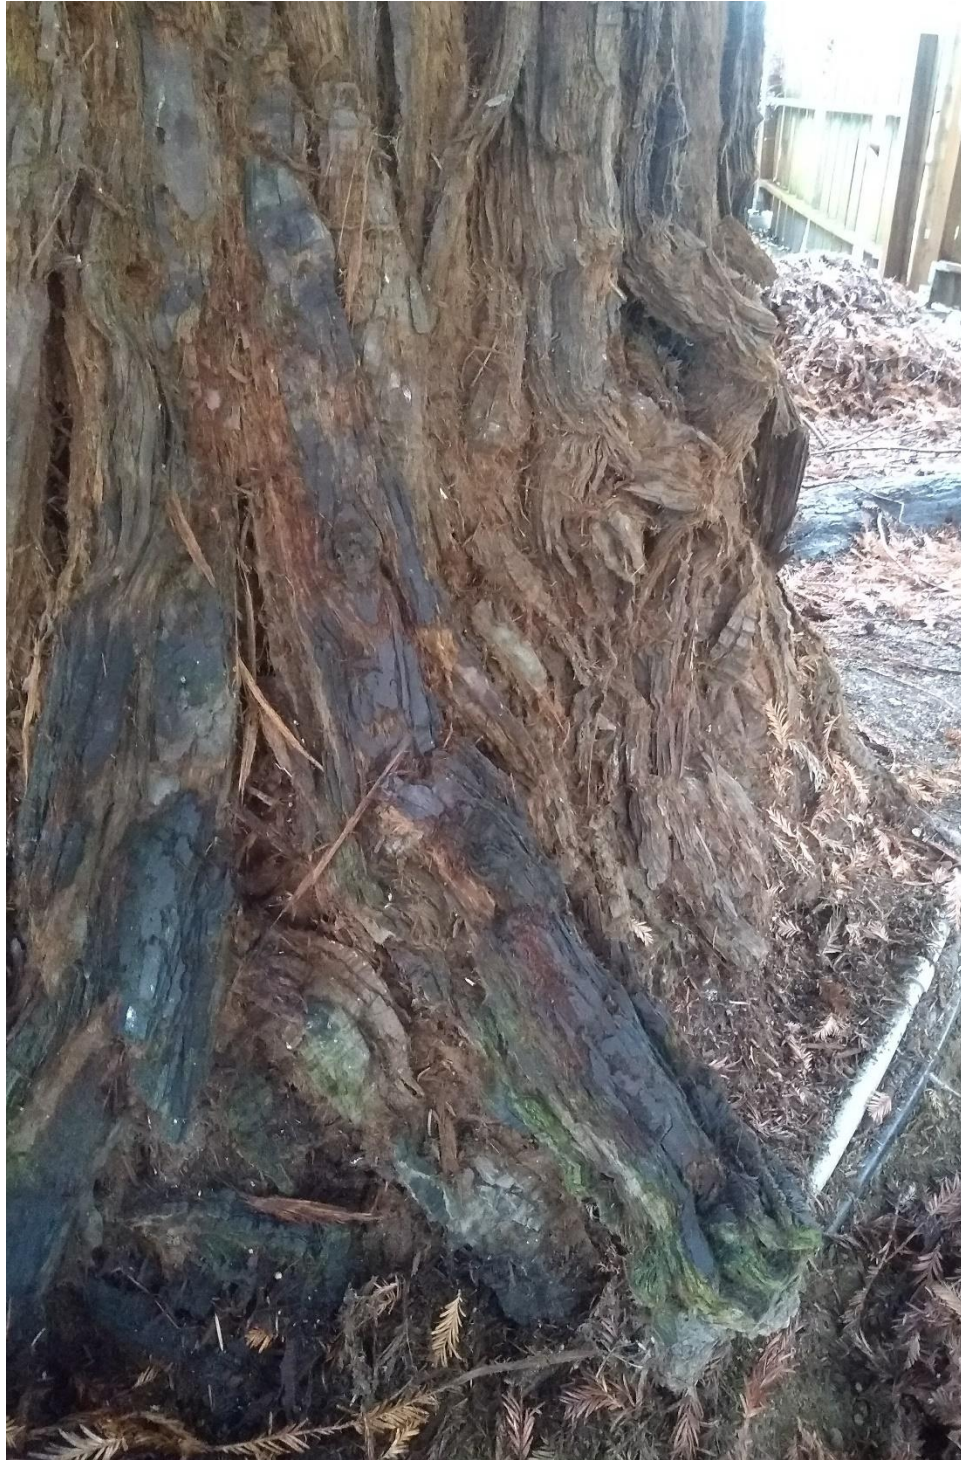
Subject tree is a *Sequoia sempervirens* (Coastal Redwood) which, although it sports a whopping girth of 7'6" **DSH** (This Arborist prefers using **diameter standard height** {4.5'} vs. "dbh" which assumes everyone is the same height or even measures 'breast' from the same portion of the chest column.), the subject tree is only 115' tall and less than 100 yrs. of age. The central stem is only 15' high when it transforms into 3 divided stems (on W, NE, and SE sides of tree) which all divide somehow (bifurcation or spike) once again near 25', with the tallest 3 showing evidence of topping (either man or natural), all @ 100'. One of these shows an obvious recent loss of half of the divided 15' high top, but I didn't see evidence of where it hit (client didn't know). Under the 3 lowest stem joins (on NW, E, S sides of tree), dark furrows in the bark run down to/near ground level. Join to E has a significant bulge underneath. Smooth bark furrows to S of bulge on main stem (same height) show long raccoon use of tree. Join to NW has abnormal bark texture running down from it in an angle downwards to the ground. Where it goes underground, a strip of bark 4" wide and between 2-3' high (depending if/how much duff is measured) has sprung up and outwards in the shape of a knee pointing outwards. I pulled back the needle litter and didn't see the buttress of the tree OR the end of the abnormality. An area of bark between 2-3' high (depending if/how much duff is measured) has sprung up and feels rigid. An additional

protruding area of bark just above it concurs in denoting movement of that portion of the stem rather than the sprung bark being an effect of possible trenching (none seen from cursory examination after pulling back needle duff) from surface-run water lines (to a swimming pool now removed from SW corner of lot). The same orientation to the tree shows a coated cable going up and along the northern most stem to a probable antenna.

Showing bark strip sprung from tree (lower right in front of water line) and above bark deformation looking S.

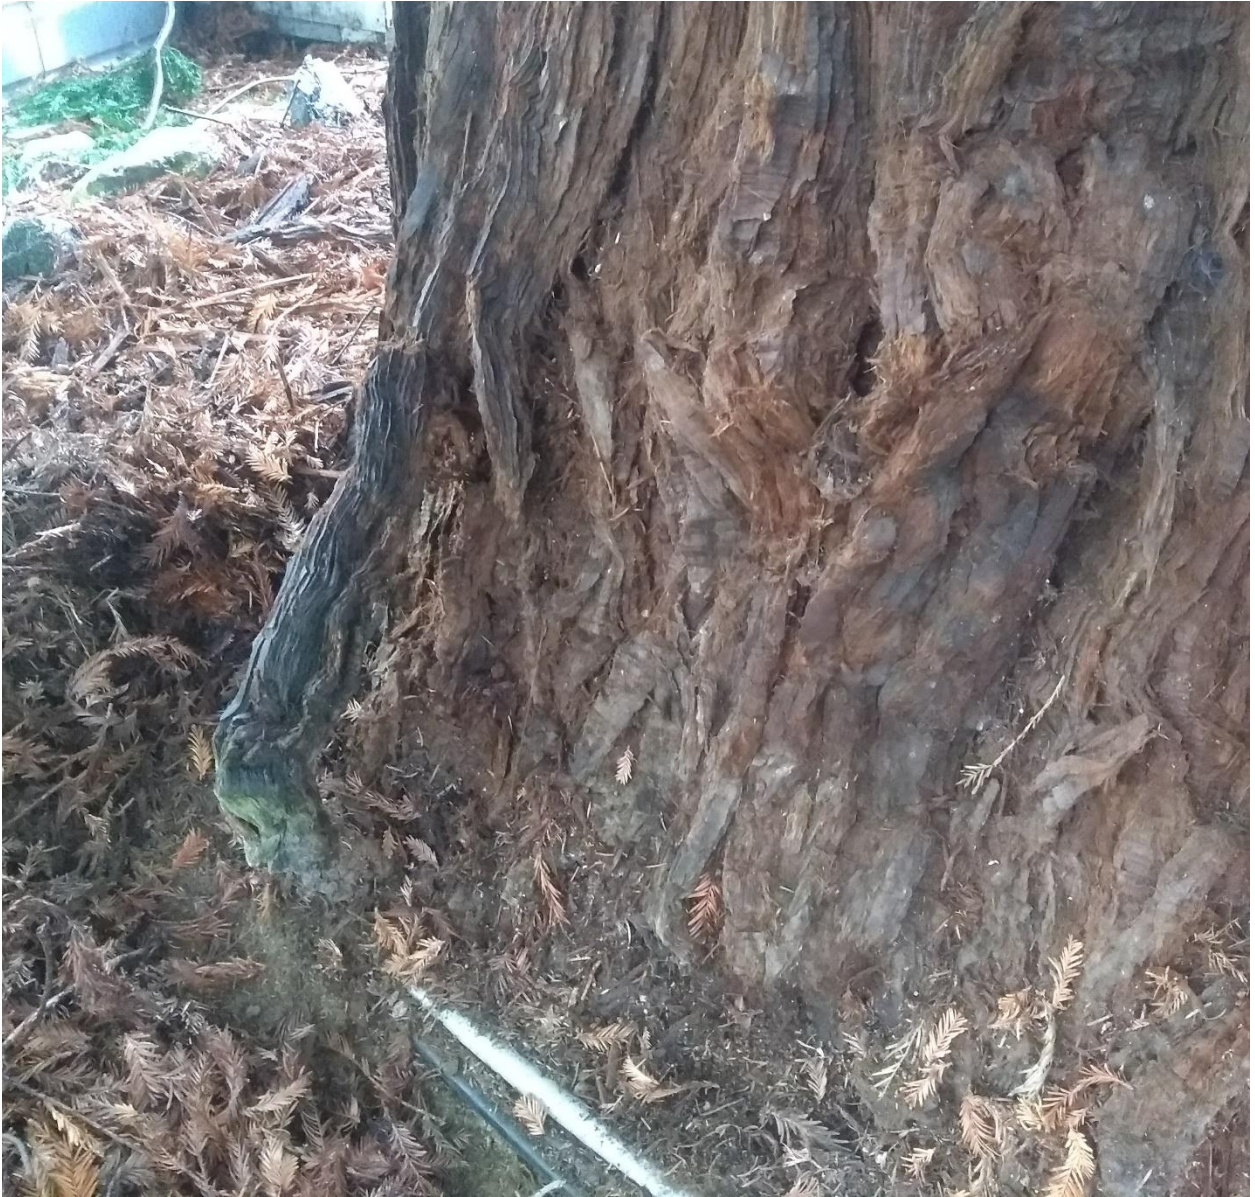
Showing bark strip sprung out and above to right bark deformation looking N.

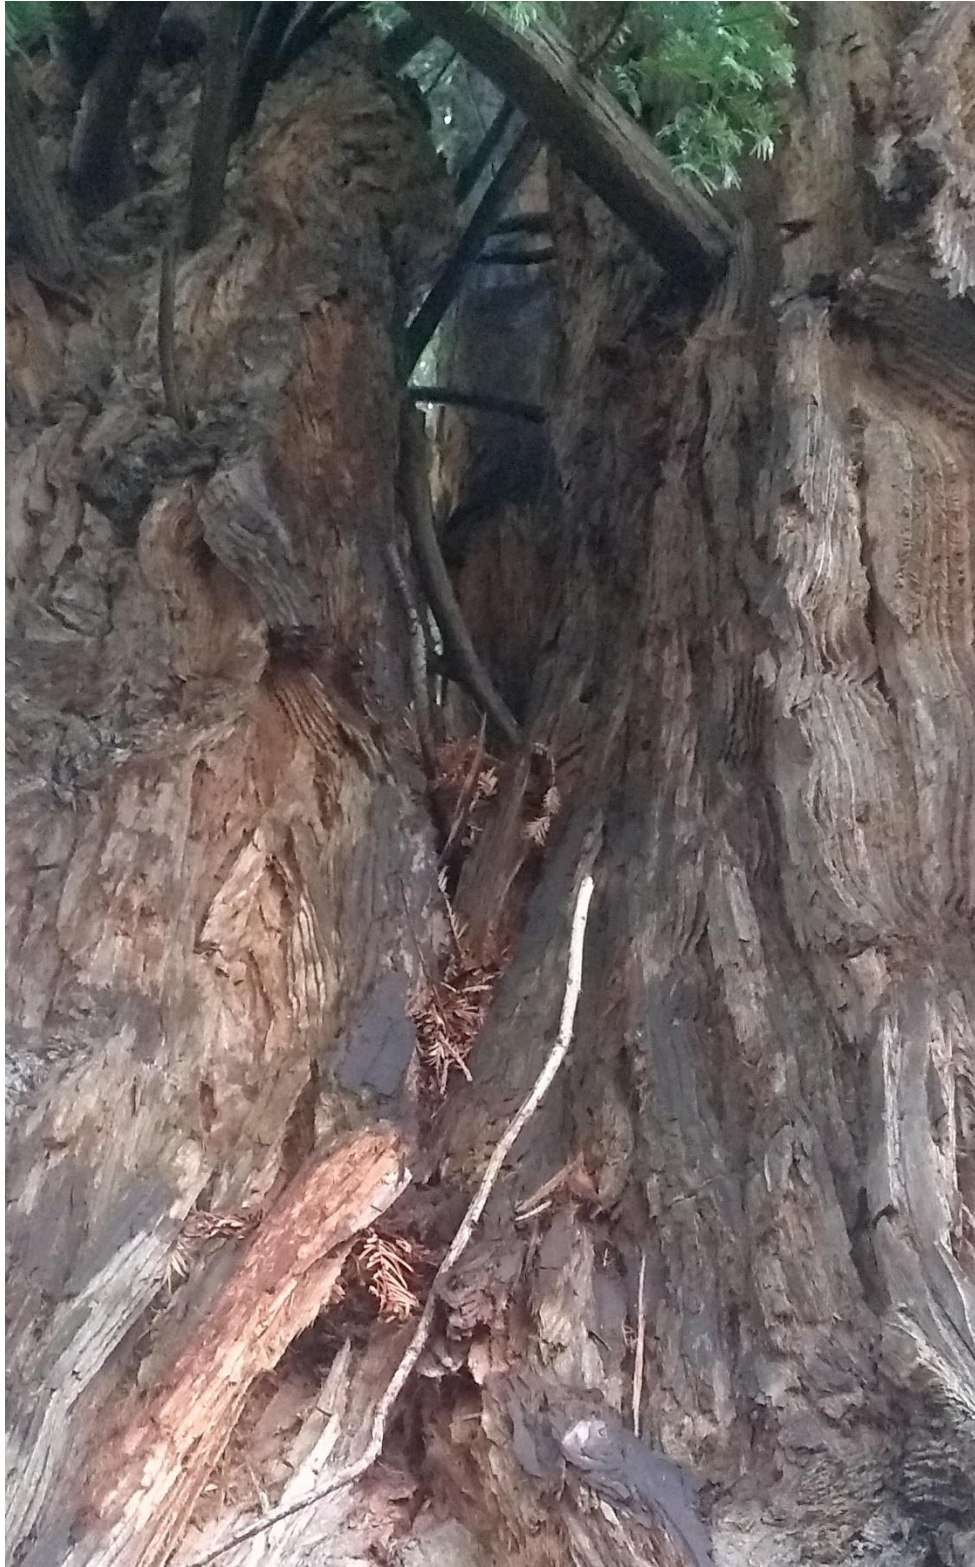
space on one side of the tree, and the increased organic debris load on many acute angle joints (These hold debris and also usually have large amounts of included bark; are considered a 'weak' tree structure because of rotting and wood grain design.). This tree holds a significant mass of multiple weakened tree parts over many targets. The question is not 'if' (as we see by the observed lost portion of W stem group top and movement of lower portion of NW stem) but 'when' a failure will occur AND if the probable failure will be of a larger or smaller portion of one stem or of the entire tree. This exotic tree makes the exuberant growth of our native trees (except possibly Black Cottonwood) pale in comparison. Coastal Redwoods can gain 400'+ (not that I think any of the tops would make it that high because of significant stem defects), grow significantly faster than our local conifers, and because of this species' usual dense canopy being tripled in this particular specimen, the ambient limb profusion acts as an excellent wind sail. The strongest root seen helps prop and feed the SW portion of the tree. The SE stem group acts as a partial wind block for both the W and NE stem groups, but only from one of the two prevailing wind directions (S/SE). The second house to the E is partially shielded by a medium sized planted tree, and is between a 1-1 ½ times tree height fall radius (used because of projectile effect of falling tree part) making it a possible target in case of full SE stem failure. House to W, client's house, and house directly to E are within the a 1x-height fall radius. Wind is strongest from the S and SE because although the tree is near the top of a hill, a larger number of taller trees in the SW direction will act as a partial reducer of wind force. Any movement in the lower stem (bark protrusions) is not a good sign and shows a portion of the tree is moving from either wind or gravity stresses. The buttressing root to SW makes full failure of the W stem less of a hazard (to the house towards the W) but an increased chance of failure (assumed rot columns begun both at top and bottom of W stem group from observed loss of half of a top with a strong, curved joint {vs. acute} and observed evidence of partial lower stem movement from bark movement) of the weak joint of the spike limb at 25' (showing discoloration), causing a large-sized tree part to fail within 3 years and strike the house to the W (due to prevailing wind direction) causing severe consequences, gives this tree its' first 'High' risk rating. The probably partially rotten NE stem group with little root buttressing/strength (due to limited root volume) also poses a 'High' risk to multiple houses. **It is likely that a strong wind from the SE will cause all or a portion of the NE stem group to fail and produce severe damage to one of two houses within a 3 year time span.** Also, because of an unseen degree of rot and limited root space, all or any individuals of the three major stem groups can possibly fail due to wind force compounding an unknown extent of probable internal heart rot decay.

Closeup of join to S showing acuteness, included bark, and debris holding capacity of one of the three lower main joins. Remember the confluence of the joins which will hold the most debris.

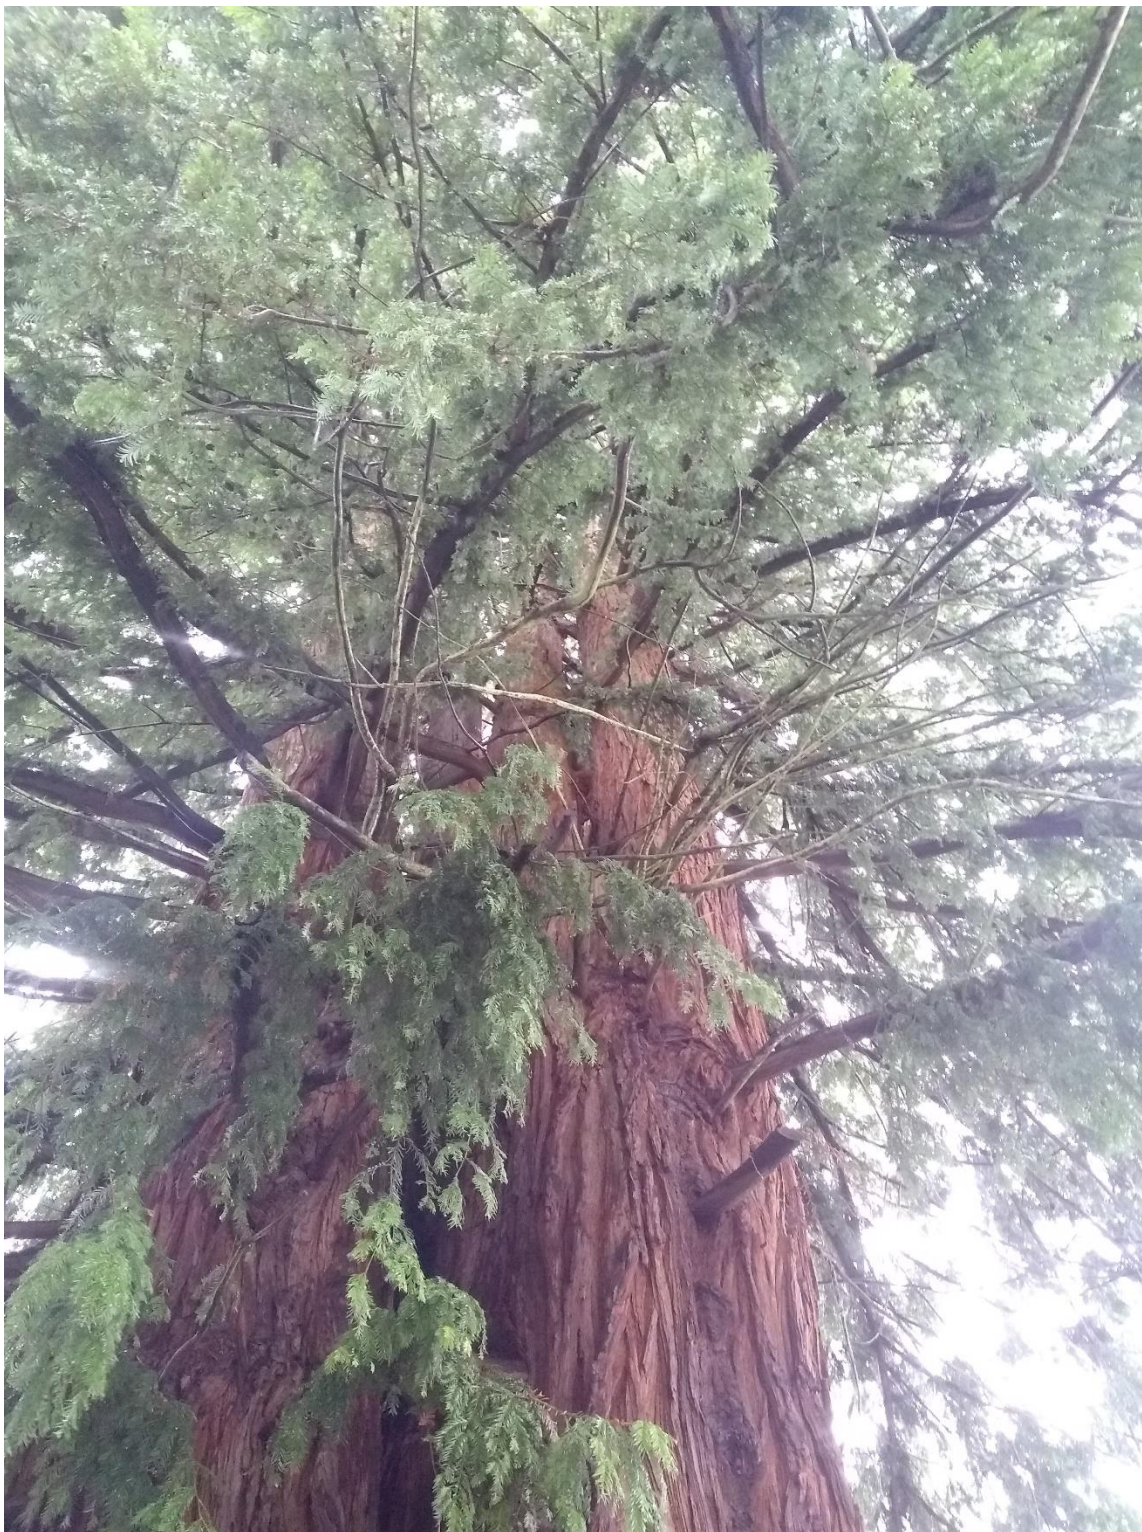
Looking up showing dense canopy and 5 percent dead limbs.

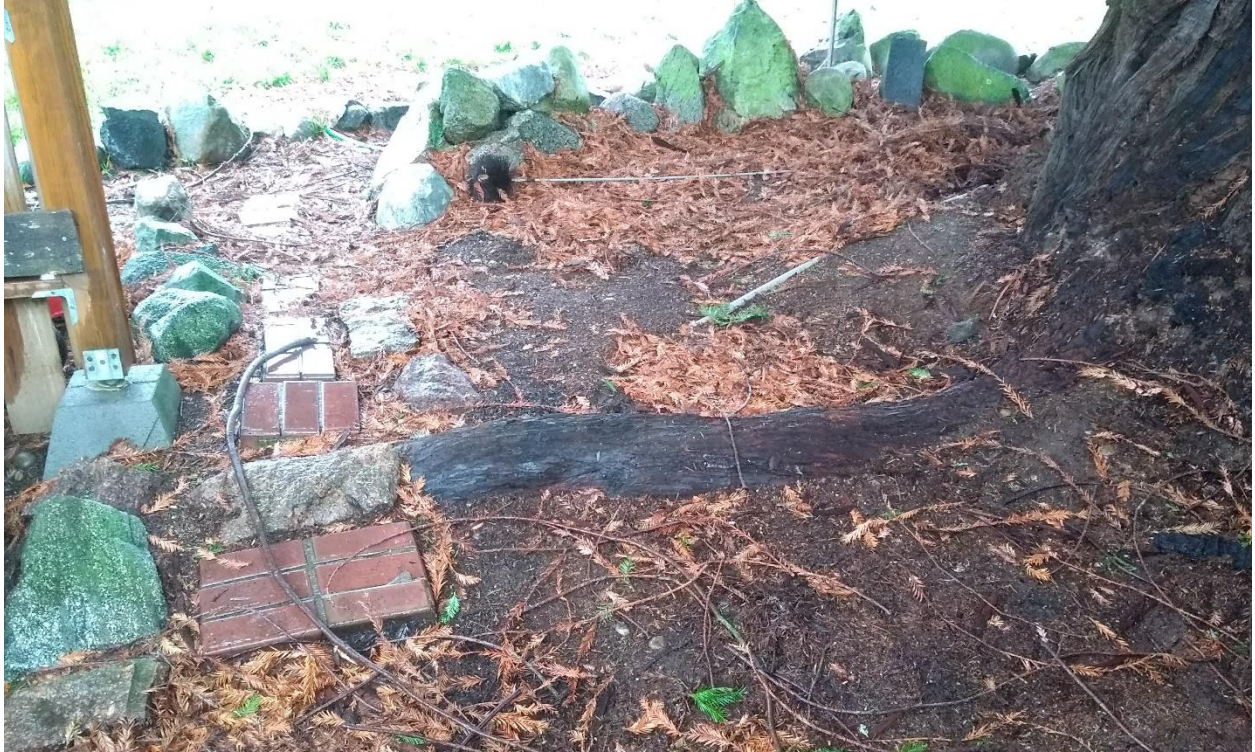
Showing only visible buttressing root traveling SW, also possible degree of fill within landscaping island.

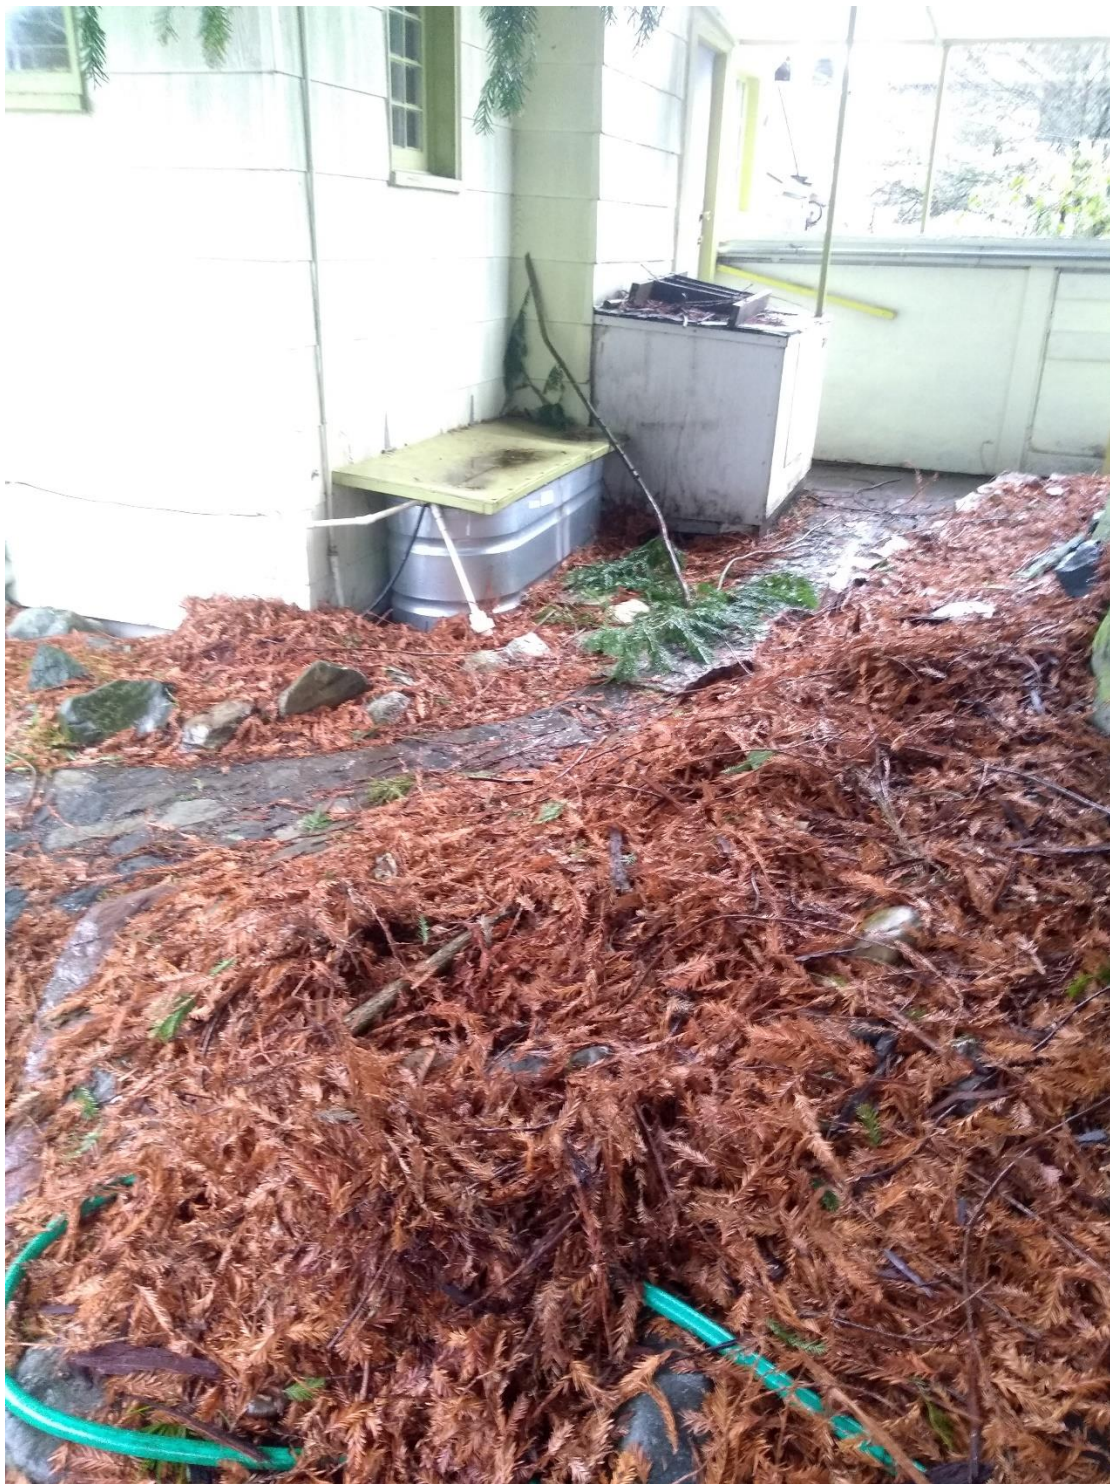
Showing two fallen limbs to 2 ½ " dia. (one partially buried behind hose) and amount of needle little (some recently moved from mortared stone walkway), looking NE.
